G1 Device Software Release Notes 3.013.00.00

vRN-G1-2024-11-v2

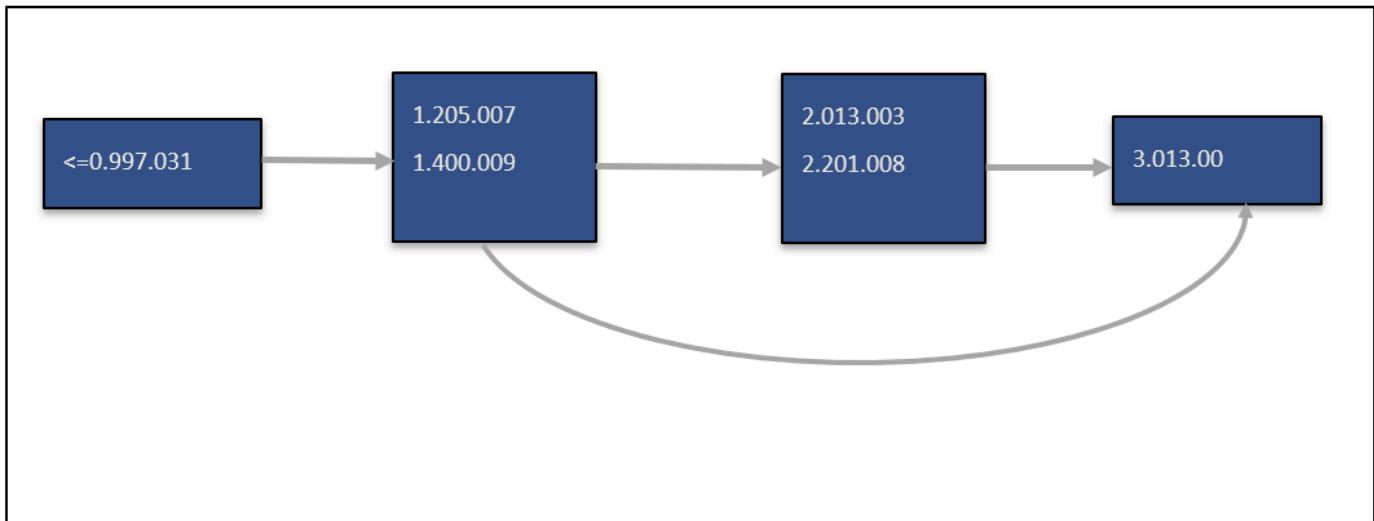
Upgrade Paths

- Please note that RNs running software older than 1.205 will not be able to connect to BNs running 3.0.13. Upgrade all RNs to one of the compatible versions before upgrading the BNs to 3.0.13.
- Any BN with a current software revision 1.205 or higher can be directly upgraded to 3.013.00.00.
- Any BN with a current software revision lower than 1.205 must be upgraded to 1.205 or 1.400 before upgrading to 3.013.00.00.
- It is recommended that the RNs be upgraded first followed by the BNs.
